ROOF FAILURES IN THE HOT-HUMID TROPICAL ENVIRONMENT: EVIDENCE FROM ENUGU URBAN, NIGERIA.

Obianuju M. Jonas, *Chidi K. Nnenanya, Ikebueze G. Chendo

Department of Architecture, University of Nigeria Enugu Campus, Enugu, Nigeria.

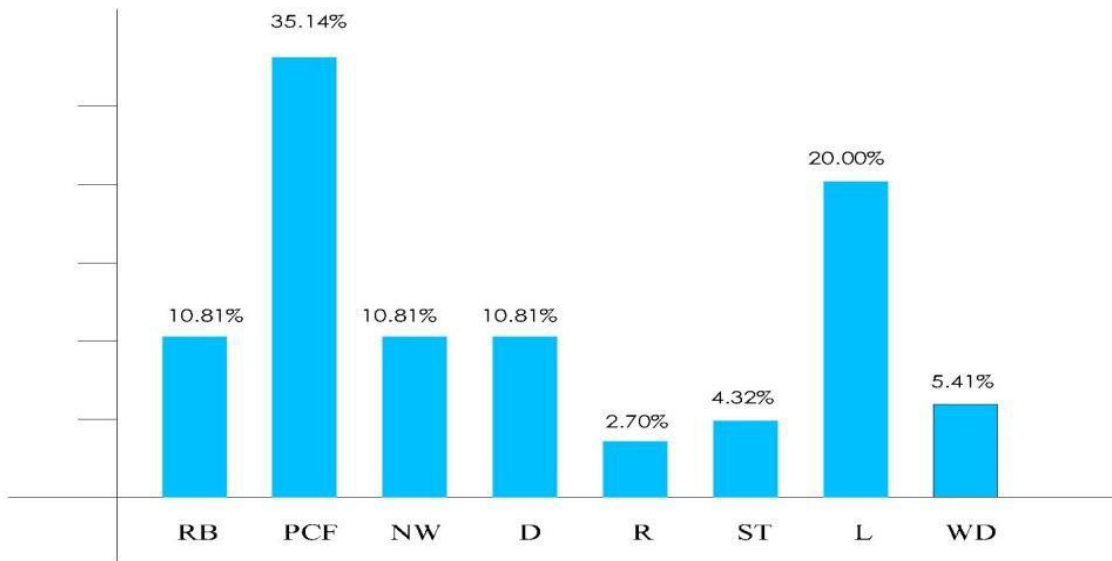
Figure 1: Percentage of roof failure by type of damage.

Table 2 shows the results of the rate, types and causes of roof failure in the neighbourhoods investigated. Data from the questionnaire survey as in Table 2 indicate that the rate of roof failure is high in Enugu urban. Also, from field observation and interviews with professionals the rate of roof failure was found to be high. Roof failure as shown in figure 1 manifests in many ways within the

neighbourhoods which include as roof blow-off, pulling of roof covering/flashing, nail withdrawal, discolouration, rusting, sagging of trusses, leakage and wood decay. However, pulling of roof covering/flashing (PCF) has the highest occurrence rate and Rusting exhibited the least.

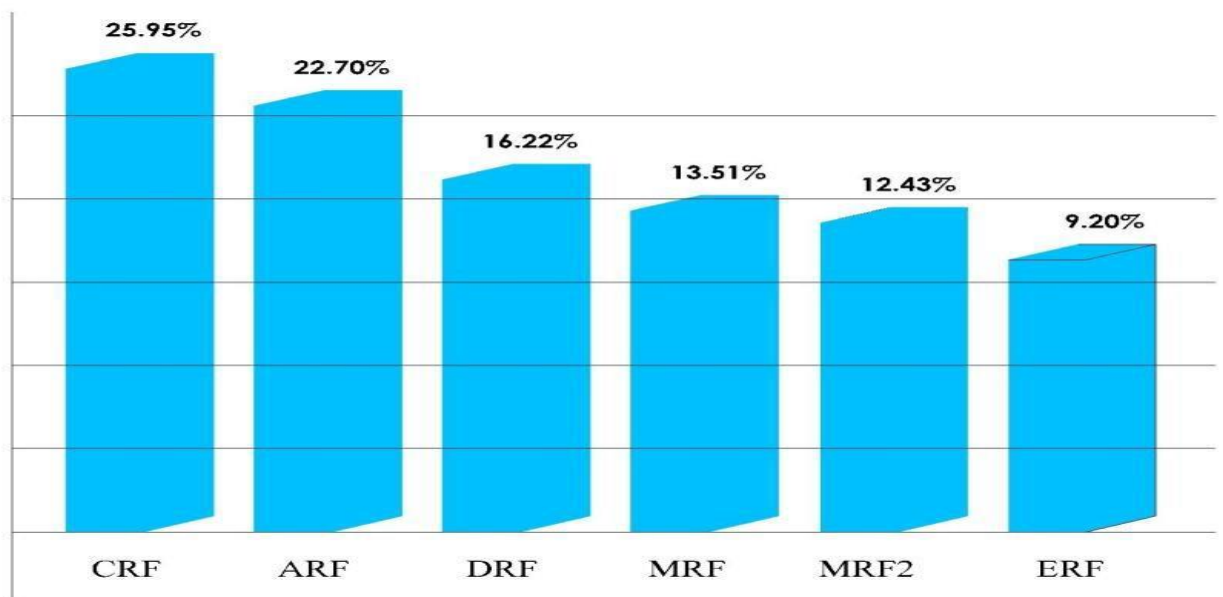
Figure 2: Classification of roof failure according to causes

Majority of the buildings with nail removal and open laps were as a result of exposure to high prevailing wind as evident in figure 2. Most cases of roof failure were construction related failure (CRF) or age-related failure (ARF)

Ongoing empirical evidence also shows that "the two most frequent causes of roof failure in the study area are related to construction and age of roof". These materials especially corrugated galvanized zinc roofing sheet is prone to rusting and discoloration over time and is supported by Adesogan (2018). Therefore, discolorations of roof coverings were common sight as obviously they cannot withstand the ultraviolet rays of the sun in the tropics. The built-up concrete roofing decking is popular among institutional buildings in Enugu Urban. This implies that most of the institutional buildings have flat roofs or low-pitched roofs. When the failure rates are compared to the life expectancy of 15-20 years of built-up roof (BUR), it suggests that this system is not conducive for use under tropical conditions. In the tropical environment, the temperature remains high through the year with a daily mean temperature of about 80–90-degree F (Aniekwu,2014). This temperature condition exposes the bituminous felt (a

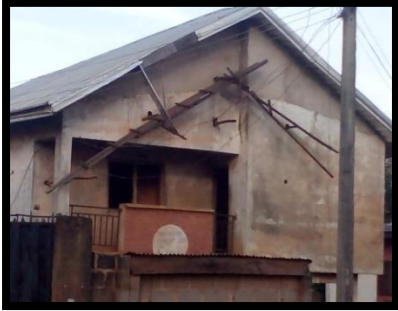
Damage Type	Photograph	Comment
1	Pulling of roof Fascia.

<p>Pulling of roof fascia/flashing in Residential building in Trans-Ekulu area.</p> <p>Roof fascia is mostly attacked by wind and should be firmly fixed. In the case of eave flashing, their fastening should be carried out with care.</p>
2	Total collapse of roof structure/trusses.

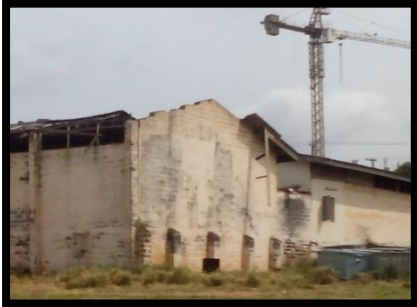
<p>Total collapse of roof structural of mechanic workshop in University of Nigeria Enugu campus. Total collapse of roof structure/trusses is often as a result of poor bracing and wood type and strength.</p>
3	Poorly maintained concrete roof gutter and spouts.

Complete roof blow off is also a common occurrence in the study area and such incidents happen mostly during heavy rain storms. Inadequately braced roofs resulting from poor workmanship were most susceptible to this kind of failure. This attitude has left so many roofs to be structurally insufficient to withstand the environmental forces of attack.

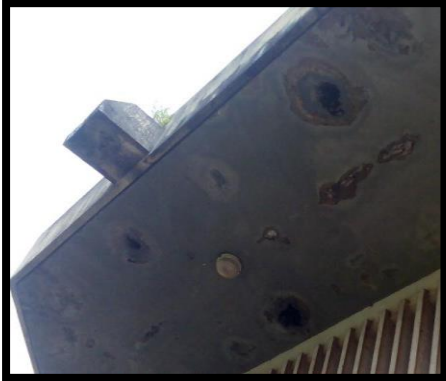
<p>Poorly maintained concrete roof gutter and spouts of a lecture hall in University Nigeria Enugu Campus.</p>
4	Reroofing as a result of low pitch.

- b. The use of low-quality roofing materials in the study area should be discouraged.
- c. Maintenance culture should be improved. People should examine their roofs regularly at least once a year after every raining season. This will enable them to detect clogged/blocked roof gutters and spouts, weak or damaged roof members, as well as leakages which might lead to further deterioration on time thereby reducing costs of repair. Heavily shaded trees around roofs should be trimmed from time to time as to reduce the amount of debris on roofs.

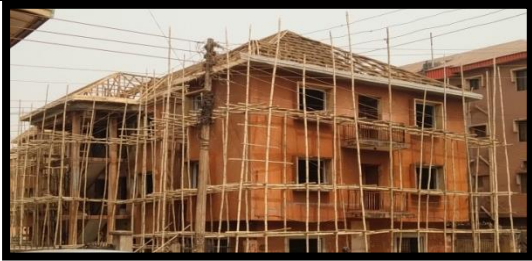
<p>Total reroofing of 3-bedroom block of flat in achara layout due to low pitch height and subsequent failure</p>

- e. More attention should be paid to roof design particularly the slope and roof overhang. The use of decked flat roof should be discouraged as it is obviously not suitable for hot-humid tropical climate.

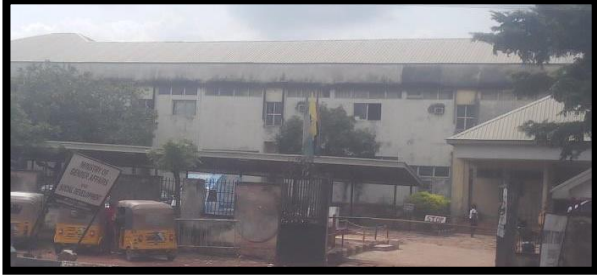
5	Defaced external walls

One common design oversight and error in the construction of roof eaves and ridges has to do with diminutive roof eave span that causes

undue exposure of external walls and other building components to incessant rain and sunlight. Consequently, the affected walls: - cement plasters, painted surfaces and other exposed materials gradually become leached, dis-coloured, and defaced besides other damages. Other design/construction deficiencies that might predispose a roof to fail due to associated weak joint also include insufficient roof slope and use of multiple ridges. Errors in construction of roof systems either as a result of lack of proper supervision by professionals or the use of under trained roofers (carpenters, installers etc.) have also a major cause of roof failure. Prevailing wind, site topography and prevailing microclimate were also some of the factors identified to have influence roof failures. Majority of the buildings with nail removal and open laps are as a result of exposure to high prevailing wind. Some materials used as roof covering in Enugu urban are inadequate either as a result of poor quality or lack of compatibility with hot-humid tropical environment.

Defaced walls as a result of inadequate roof eave at Enugu State Ministry of Gender affairs and Social Development Building (Independence layout)
6	Failed barrel vault concrete roof.

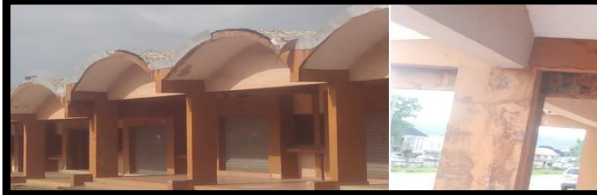
A failed concrete roof now covered with stepped long span aluminum sheet as well as defaced walls due to water seepage from failed concrete at Trade fair complex (Golf Estate)
7	Discolouration of roofing sheet.

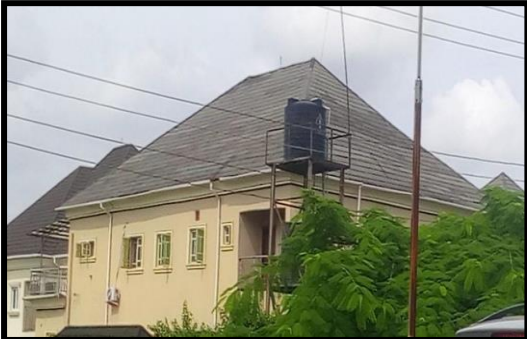
Discolouration of sand coated acrylic roofing tiles in New haven
8	Failed flat roof.

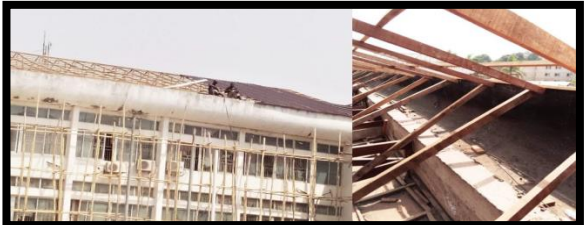
Failed flat roof being re-roofed in an institutional building (GRA).

waterproof membrane) to damage. Failure ultimately results from the inability of the felt (which is generally of mats of organic or inorganic fibers coated and impregnated over a solid concrete deck) to withstand more than slight amounts of stretching without tearing or splitting. Aniekwu, (2014) also asserts that the standard tests to which these materials are subjected to before certification are designed for climatic conditions considerably different from those of the tropics. The B.S. 747, for instance, specifies requirements for countries having a climate similar to that of the British Isles. This climate condition is not a tropical type and consequently cannot be adequate for certification of materials for use under tropical exposure. It was observed therefore that a number of flat roofs had been re-designed to pitch roofs, to suite the tropical conditions of the study area.
